## Concrete Pipeline Systems

# Testing of pipe materials' resistance to high-pressure water jetting (Report 1)

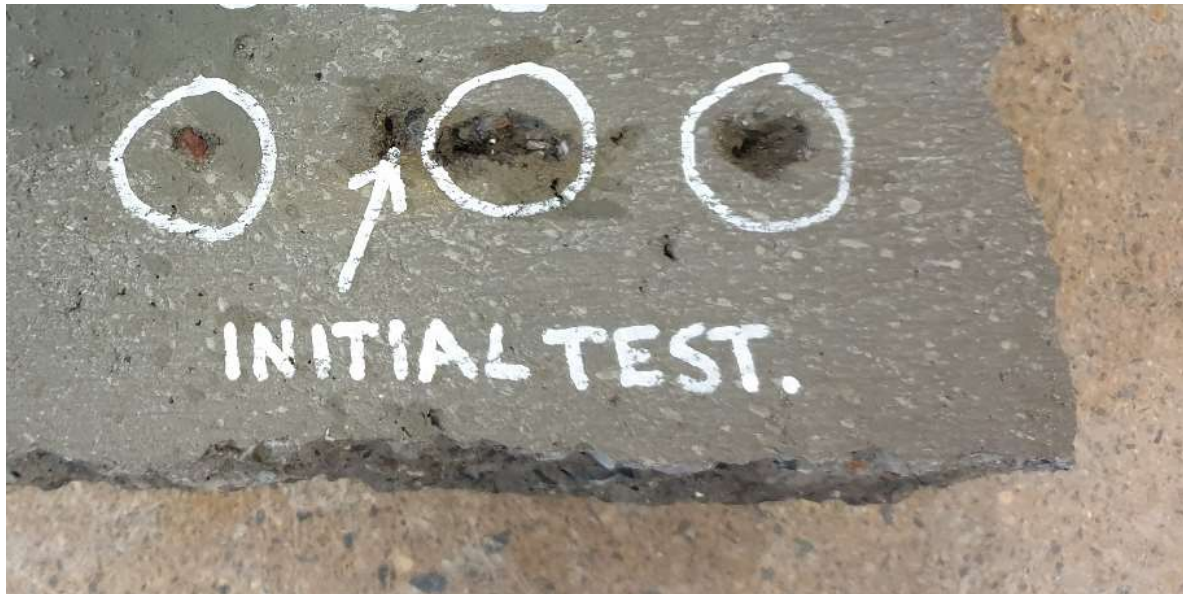
A BPDA member company DN 450 concrete pipe with wall thickness >60mm was tested. After 3 minutes of testing, surface damage was detected at all jetting sites, varying in depth from 3.3mm to 6.8mm. All sites would still pass gauging for maximum surface void size as specified in Draft BS 5911-1:2020.

Figure 1. Sample 1 after testing.

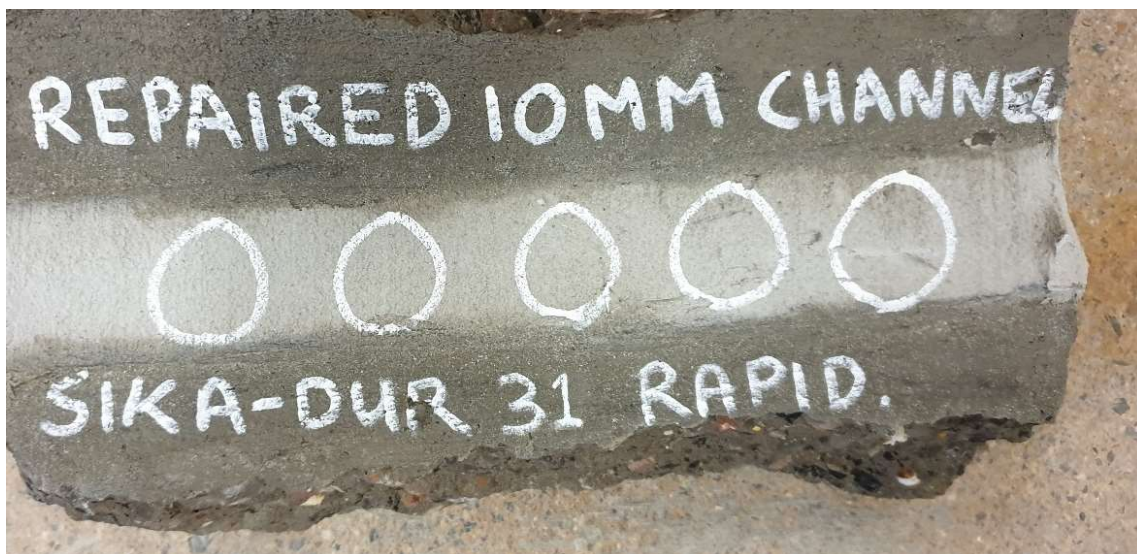
A BPDA member company DN 450 concrete pipe with a repaired 10mm deep x 10mm wide channel<sup>1</sup> was tested. No visible damage was caused by the water jet at any of the jetting sites tested.

Figure 2. Sample 2 after testing.

<sup>1</sup> Repair material used: Sika-Dur 31 Rapid, two-part repair mortar.

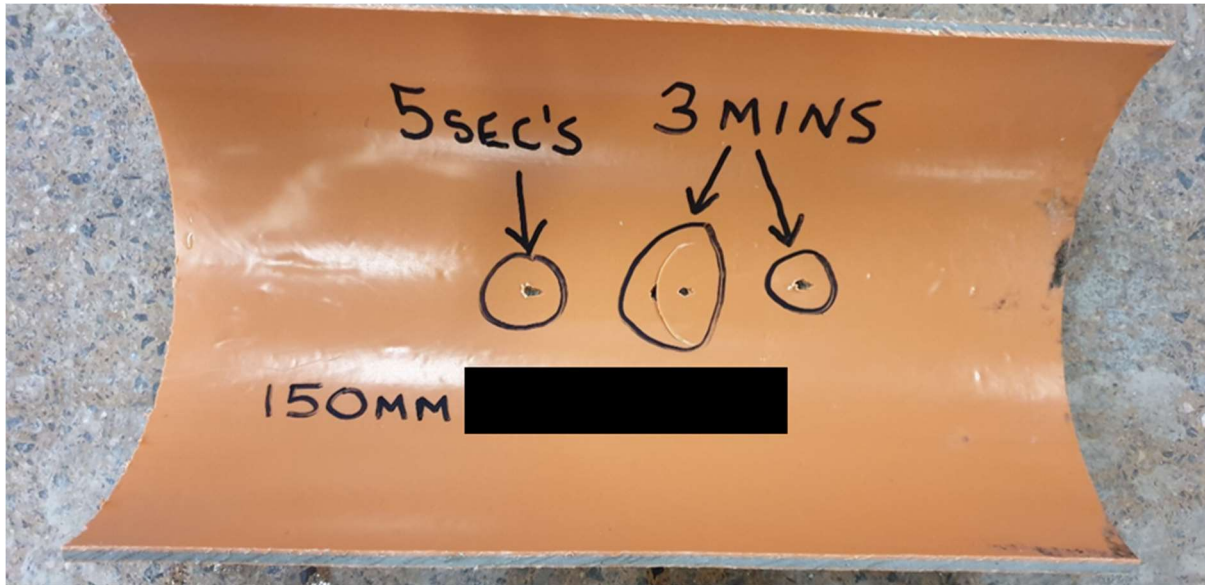
One uPVC pipe type DN150 was tested. The jetting water pierced the surface of all three sites tested after only 5 to 10 seconds.

The jetting water then dispersed through the core material within the wall and raised blisters on the inner surface, allowing the jetting water to escape internally. But water did not pierce

the full wall depth of the pipe after three minutes of test duration. Blister size approximately 50mm in diameter.

Figure 3. Sample 3 after testing.

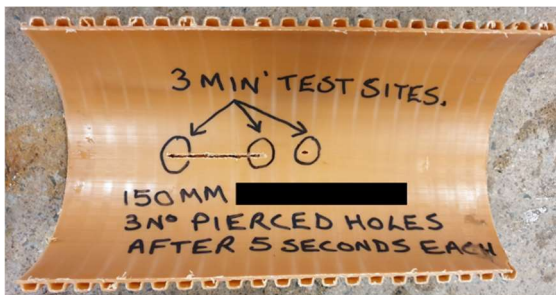
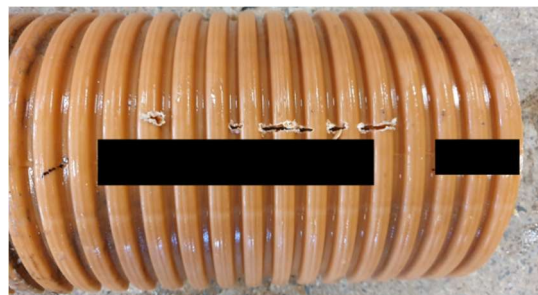
One Double-wall type DN150 plastic pipe was tested. All three jetting test sites pierced the inner surface after 5 seconds and quickly continued to pierce through the full wall depth.

Figure 4. Sample 4 after testing.

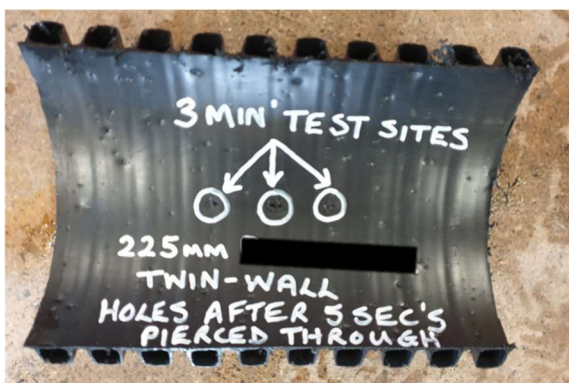
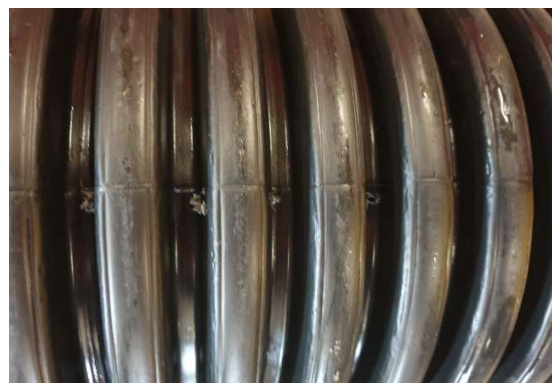
One double-wall type DN225 pipe was tested. All three jetting sites tested pierced the full wall depth of the product after approximately 5 seconds.

Figure 5. Sample 5 after testing.

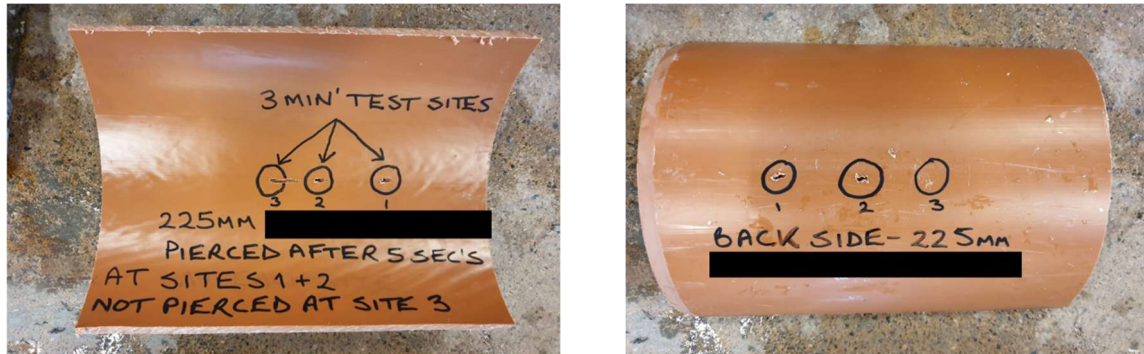
PVC pipe with smooth external & internal surface was tested. All three jetting sites tested pierced the inner surface after approximately 5 seconds and two out of the three sites pierced the full wall depth of the product a few seconds after.

Figure 6. Sample 6 after testing.

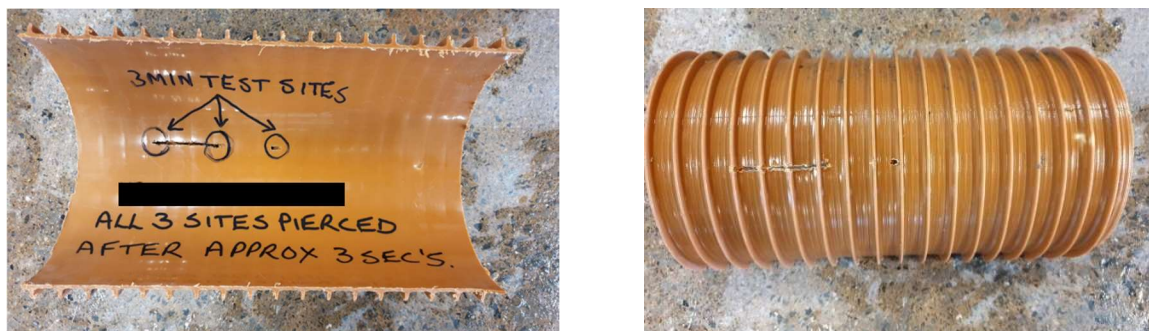
uPVC type DN150 plastic pipe was tested. All three sites tested pierced the inner surface after approximately three seconds and continued to pierce the full wall thickness after several more seconds under the test.

Figure 7. Sample 7 after testing.

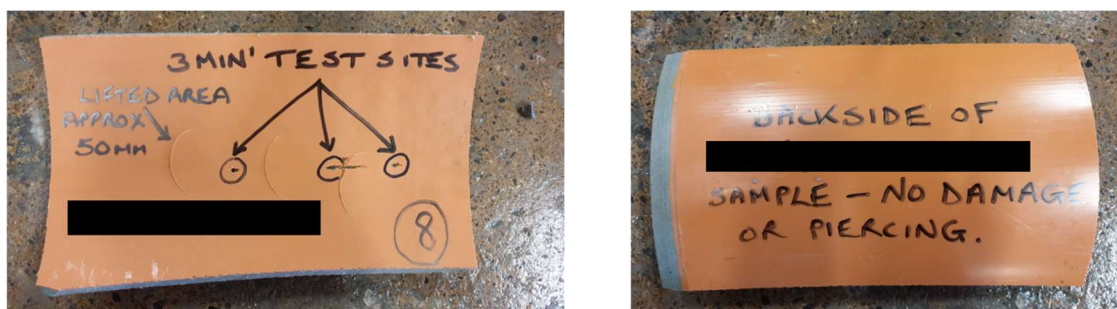
uPVC pipe type DN375 was tested. All three jetting sites tested pierced the inner surface after several seconds. The water jet then dispersed into the inner recycled core material until after approximately one minute of testing. The inner surface material blistered adjacent to each test site, allowing the water jet to escape internally. The blister sizes were approximately 50mm in diameter. No damage was detected in the outer surface of pipe.

Figure 8. Sample 8 after testing.
